AIRBAG INVESTIGATION

CASE NO. 93-05

TECHNICAL REPORT

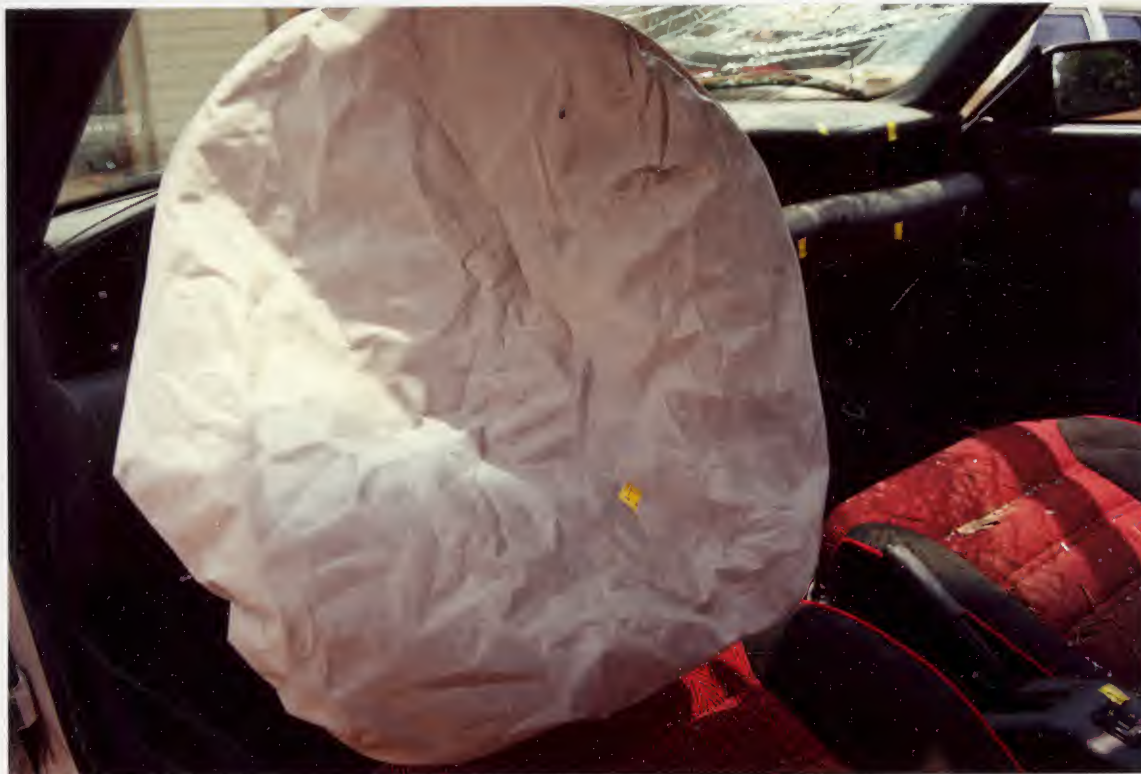
31. Overall view of deployed airbag showing possible occupant contact.

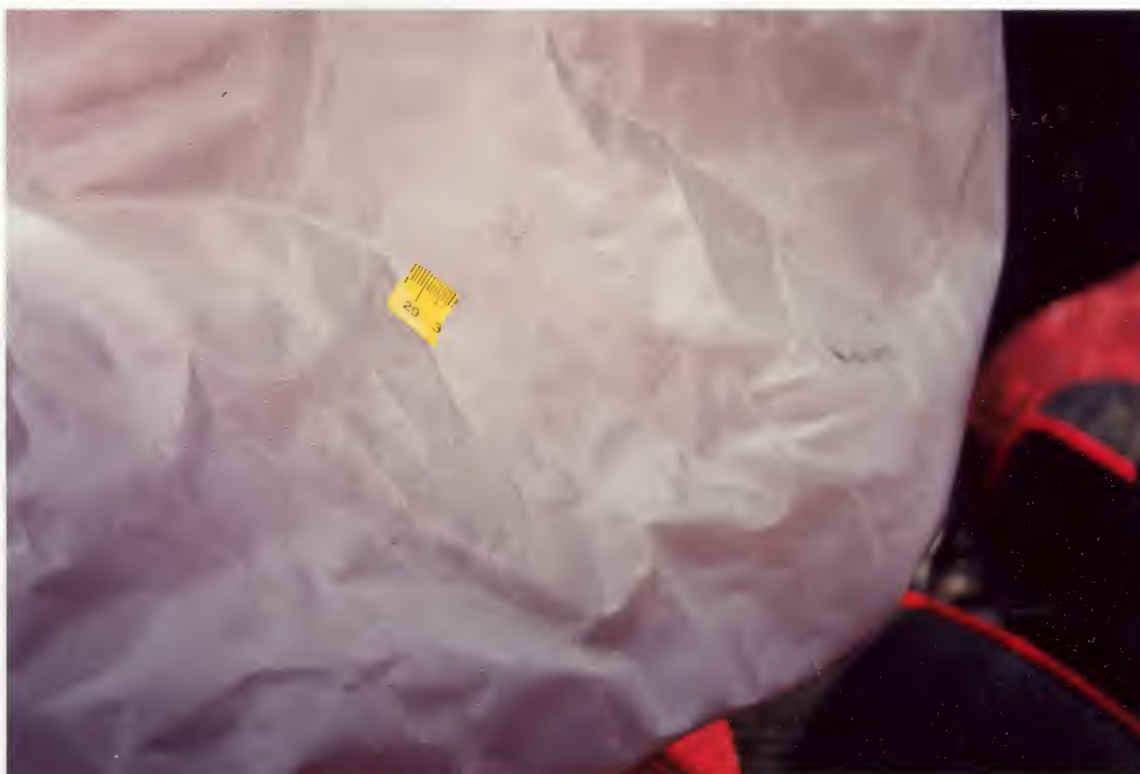
32. Closeup view of possible make-up transfer on deployed airbag.

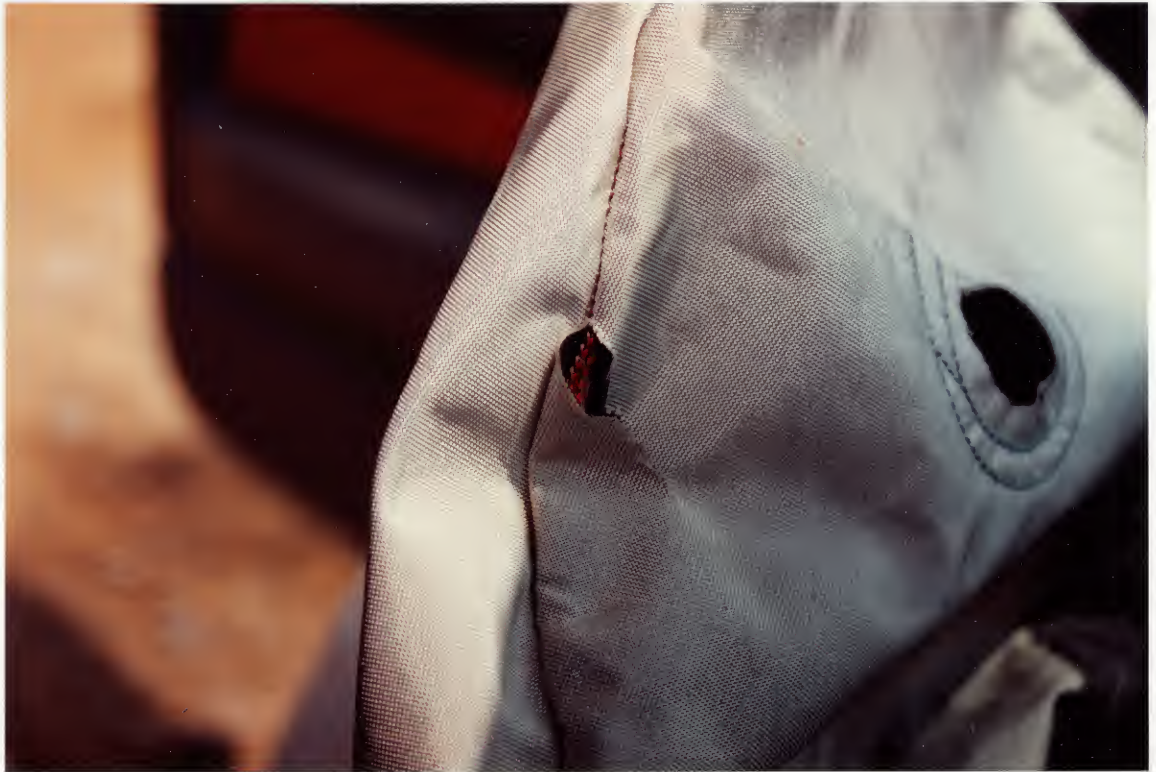
33. Views of slight tear in airbag material and unobstructed vent holes in the back of the airbag.

A SMALL (LESS THAN  
 1") TEAR WAS  
 PRESENT ON THE BACK  
 SURFACE OF THE  
 AIRBAG @ APPROX.  
 10 O'CLOCK

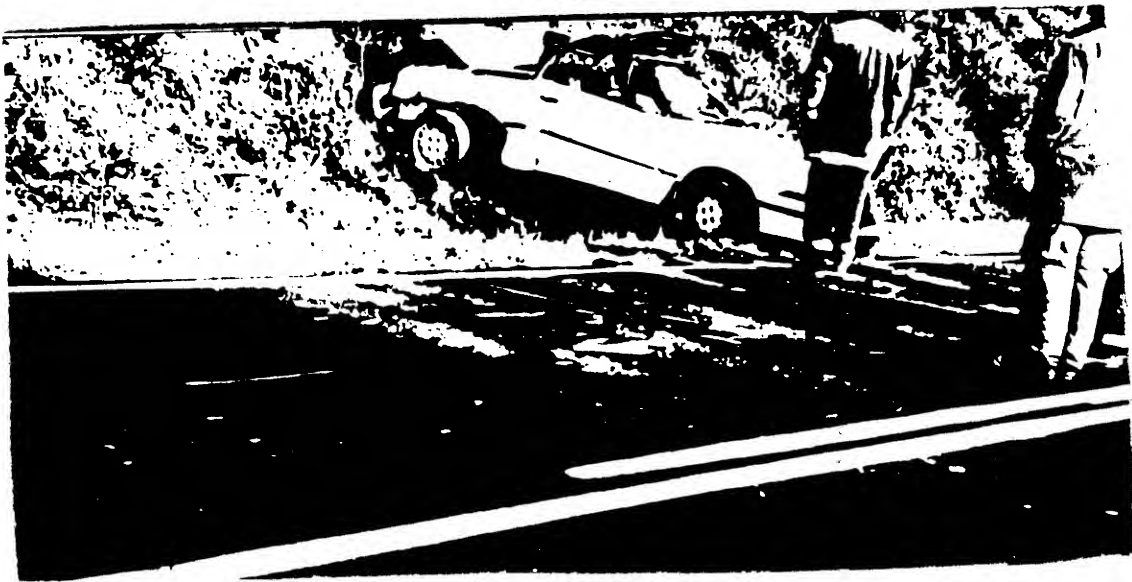
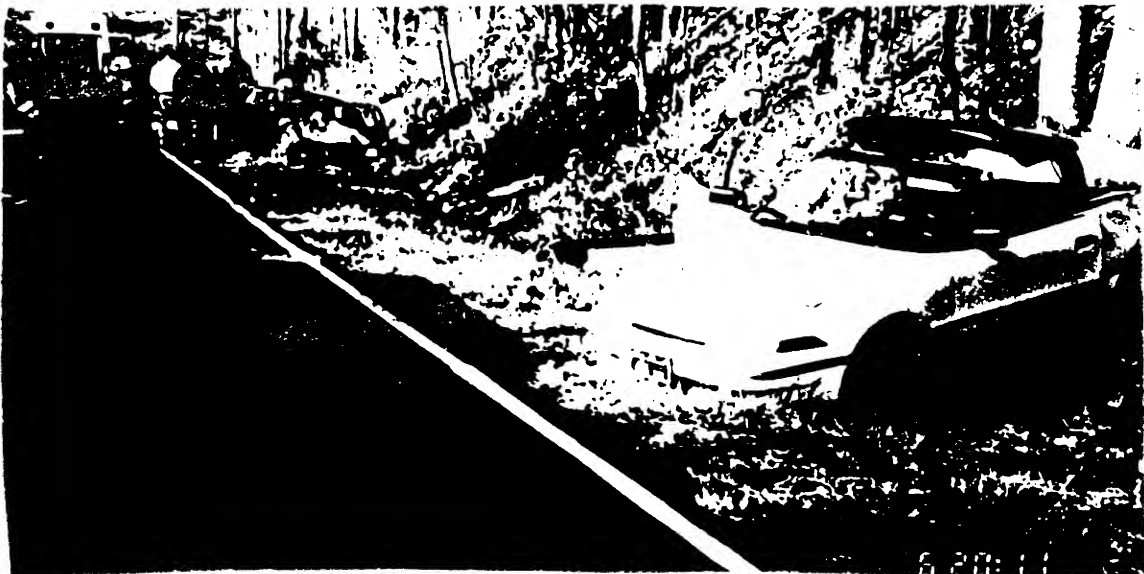
Photos of the 1991 Mercury Capri convertible (light colored vehicle) and 1986 Grand Am (dark vehicle) at final rest.

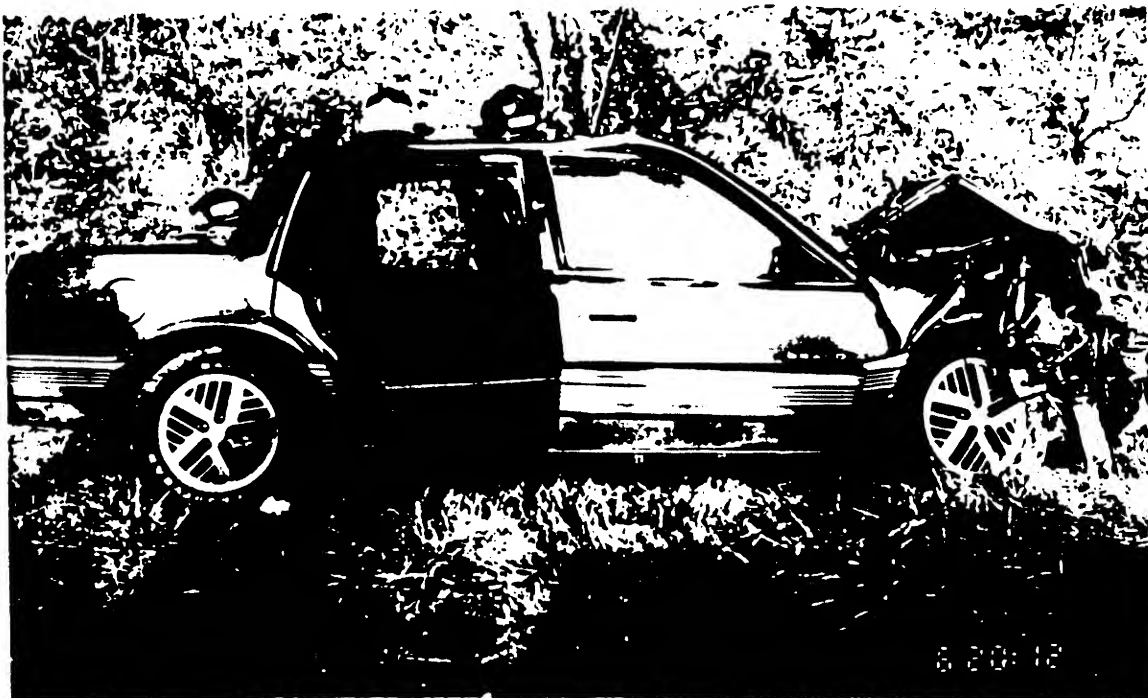
Photos of damage the Grand Am. These are copies of the police photos taken at final rest.

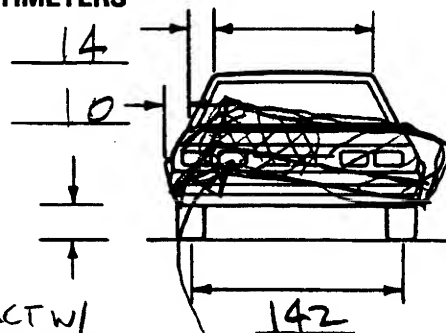
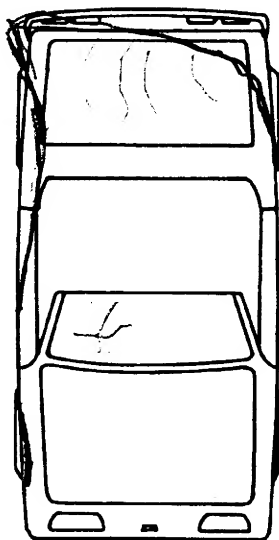
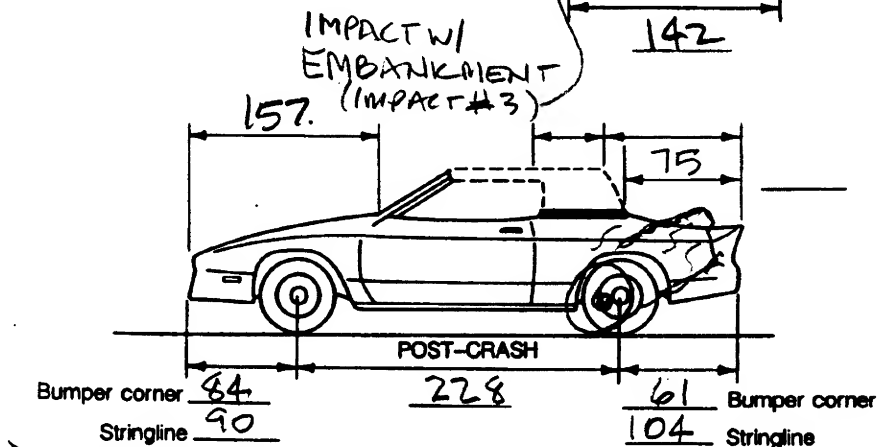
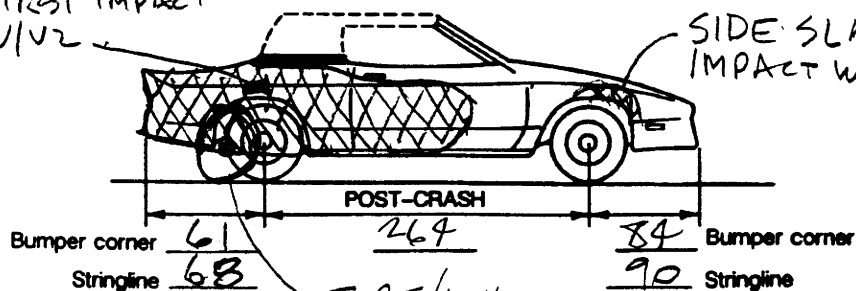
DEPLOYMENT IMPACT -  
FIRST IMPACT  
W/V2

TIRE/WHEEL  
DISPLACED  
REARWARD
